# Crossover: Testing Solutions and Assessing Savings for Water and Energy in Low-Income Multifamily Affordable Housing

A report by the Association of Energy Affordability and the California Housing Partnership for the San Francisco Foundation

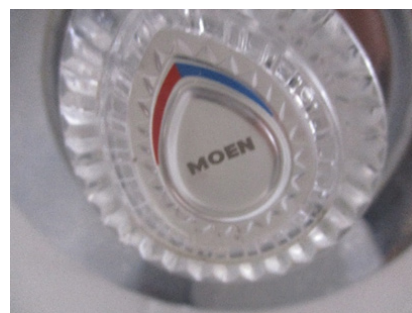
Figure 3. Moen Push/Pull shower valve containing a Moen 1200 cartridge. Unless the cartridge has been replaced with a Moen 1225 cartridge, it can be assumed all Moen shower valves contain Moen 1200 cartridges.

Shower Valve Types	Shower Cartridge Model	More Susceptible to Crossover?	Recommended Replacement
Moen	Moen 1200	Yes	Moen 1225 or NoMix Cartridge
Mixet	All	Yes	NoMix Cartridge
Delta	All	No	Same or Newer Version of Existing Cartridge
Pfister	All	No	Same or Newer Version of Existing Cartridge
American Standard	All	No	Same or Newer Version of Existing Cartridge
Kohler	All	No	Same or Newer Version of Existing Cartridge

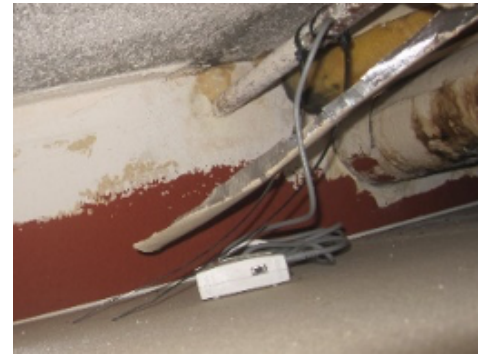
*Figure 4. Temperature Data Logger Monitoring a Return Riser*

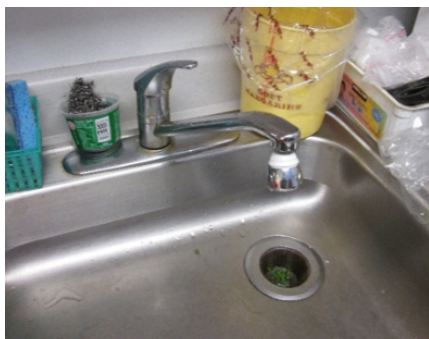
Figure 10. Presentation Senior Single Handle Kitchen Faucet

<b>All Three In-Unit Fixture Types</b>	Determine which riser/stack of units is experiencing the most severe crossover utilizing the water temperature logging data and time to temperature data. Apply the following to each unit in the stack of units: <ol style="list-style-type: none"> <li>1. Install new cartridges in shower valves.</li> <li>2. If existing shower valve contains known susceptible to crossover cartridge, then replace with retrofit cartridge (refer to shower cartridge section above).</li> <li>3. Service or replace faucet mixing cartridges.</li> <li>4. If working with the existing fixtures isn't possible, install check valves at the hot supply and cold supply lines to each unit. Check valves should be accessible for maintenance.</li> <li>5. Test riser using either the time to temperature method or the temperature data logging method to verify the repair improved the crossover issues. If the fixes above improved the crossover symptoms then expand scope to the rest of the building.</li> </ol>

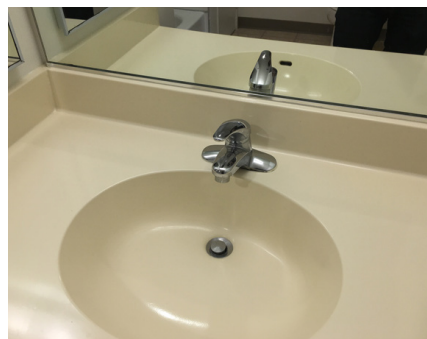
Figure 11. Presentation Senior Single Handle Bathroom Faucet

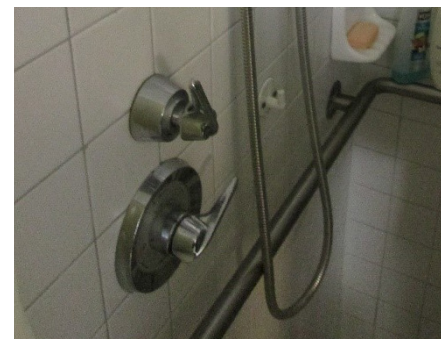
Figure 12. Presentation Senior Shower Valve

Proven Source of Crossover	Recommended Repair
<b>Shower Cartridges</b>	If the crossover investigation suggests that risers which serve in-unit showers are showing signs of crossover and the cartridges have either not been frequently replaced (every 3-5 years) or are known to be susceptible to crossover then the shower cartridges should be replaced with newer versions of the same brand or a version of that cartridge that is known to be less susceptible to crossover (Table 5).
<b>Mop Sinks</b>	If the DHW risers, which serve the mop sinks show signs of crossover in the temperature data then determine why these mop sinks are a source of crossover and repair them accordingly. This would likely be the result of a faulty mixing valve. Check valves can also be installed on the hot and cold water lines connected to the mop sink.
<b>Laundry Rooms</b>	If the temperature data or visual inspections showed signs of crossover occurring in the laundry rooms, then there are two potential repair options: <ol style="list-style-type: none"> <li>1. Conduct more diagnostic testing or visual inspections to determine if the crossover is occurring at a specific fixture and then complete the necessary repairs to fix it</li> <li>2. Install check valves on the cold and hot plumbing lines, which branch off a riser. These check valves should be accessible for maintenance.</li> </ol>

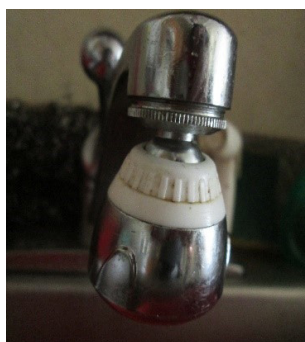
Figure 13. Padre Apartments  
Single Handle Kitchen Faucet

<b>Laundry Rooms</b>	Refer to Table 9 in <b>Presentation Senior: Recommended Crossover Repairs Based on Hypothesized Results</b>
<b>All Three In-Unit Fixture Types</b>	Refer to Table 9 in <b>Presentation Senior: Recommended Crossover Repairs Based on Hypothesized Results</b>
